**DEPARTMENT OF TRANSPORTATION****DIVISION OF ENGINEERING SERVICES**

Contract #: 04-0120F4Cty: SF/ALA Rte: 80 PM: 13.2/13.9File #: 1.28**WELDING INSPECTION REPORT****Resident Engineer:**Pursell, Gary**Address:** 333 Burma Road**City:** Oakland, CA 94607**Report No:** WIR-014693**Date Inspected:** 04-Jun-2010**Project Name:** SAS Superstructure**OSM Arrival Time:** 700**Prime Contractor:** American Bridge/Fluor Enterprises, a JV**OSM Departure Time:** 1530**Contractor:** American Bridge/Fluor Enterprises, a JV**Location:** Job Site**CWI Name:** See Below**CWI Present:** Yes No**Inspected CWI report:** Yes No N/A**Rod Oven in Use:** Yes No N/A**Electrode to specification:** Yes No N/A**Weld Procedures Followed:** Yes No N/A**Qualified Welders:** Yes No N/A**Verified Joint Fit-up:** Yes No N/A**Approved Drawings:** Yes No N/A**Approved WPS:** Yes No N/A**Delayed / Cancelled:** Yes No N/A**Bridge No:** 34-0006**Component:** Orthotropic Box Girders (OBG)**Summary of Items Observed:**

**Field Splice 5E/6E Face A (Outside) Repairs**

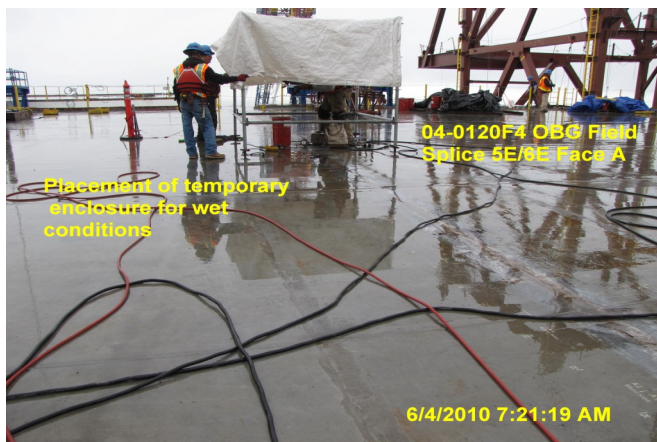
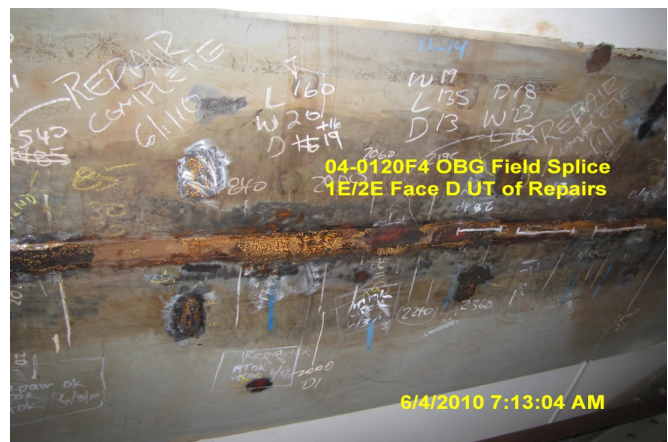
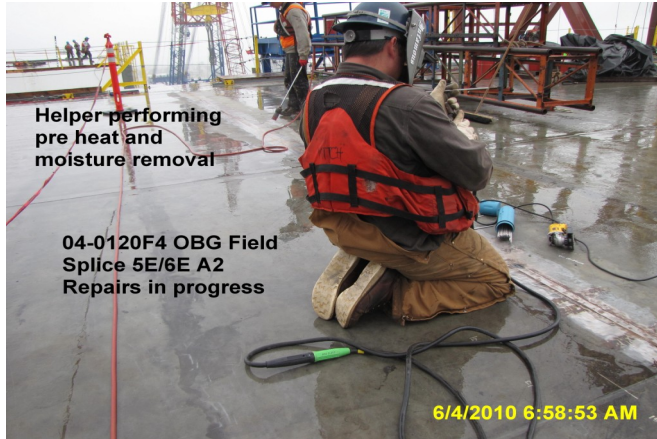
The QA inspector periodically observed ABF welding personnel Mitch Sittinger and Fred Kaddu performing shielded metal arc welding (SMAW) for repair areas previously identified by the QC department during ultrasonic testing (UT) of the deck plate. It was noted Mr. Sittinger was performing welding operations at weld numbers A-1, A-2 and one at A-3 with Mr. Kaddu performing repairs primarily at A-3 and A-4 as the shift progressed. QC inspector Steve McConnell was noted to be present in order to monitor the progression of work and adherence to welding procedure specification designated as ABF-WPS-D1.5-1001 Repair. The welding parameters were verified to be within the WPS as observed by the QA inspector with the QC inspector performing the readings periodically. The pre heat and interpass temperatures were within the WPS and the contractor was utilizing helper personnel in order to keep moisture away from the excavations while welding was in process due to misty conditions. After a short time, contractor personnel placed temporary shelters at the welding locations to further assist in keeping the work dry. See digital photo included in the body of this report for clarification. The work progressed throughout the QA inspectors shift with 6 areas completed, which appeared to be in general compliance

The QA inspector periodically observed the in process Flux Cored Arc Welding (FCAW-G) being performed by ABF welding personnel Song Tao Huang between Y locations designated 4000-5280mm. QC inspector Bernard Docena was noted to be present in order to monitor the progress and ensure the welding was within the established Welding Procedure Specification (WPS) noted as ABF-WPS-D1.5-3042B-1 and supporting Procedure Qualification Records (PQR). The preheat and interpass temperature was verified by the QC and QA inspector to be within the established WPS and the parameters were verified to be 250 amps, 24 volts with a measured travel speed of 260mm/min. The work alternated between the semi automated welding equipment and manual manipulation as the access in this area is limited in nature. The work progressed throughout the shift, was not completed and appeared to be progressing in general conformance with the contract documents. See digital photo included in the body of this report for general information.

The QA inspector performed a random visual review of the status of the ultrasonic testing (UT) for this location in which the initial repairs have been completed and the QC department has performed additional UT on a portion of these locations. The QA inspector did not observe any QC inspector performing the UT at the time of review however, several additional areas have been marked for what appears to be rejectable indications. A digital photo is included in the body of this report for general information. The QA inspector inquired from QC inspector Jessie Cayabyab if he was completed with the UT scan and he relayed the review was still in process as additional rejectable indications were discovered during the scan and several areas marked need further evaluation. No remedial work was performed at this location for the QA inspector's shift.
